American Inspections, Inc.
403 Stonehaven Lane NE
Cedar Rapids, IA 52402

Professional Inspection Report

123 Example Rd
Iowa City, IA 52402

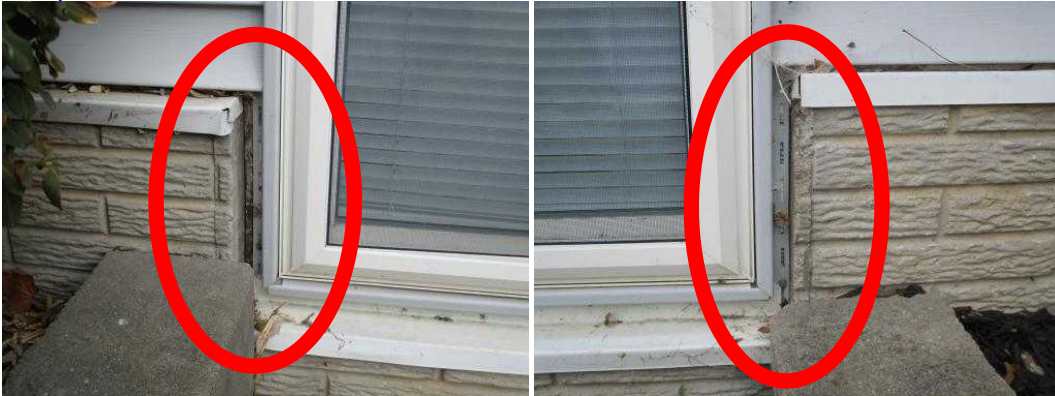
The basement family room's West window lacked a weather resistant barrier and trim at the lower corners (between the window and the concrete foundation). Installation of an adhesive window flashing tape and trim or other cladding material is recommended for better weather protection.

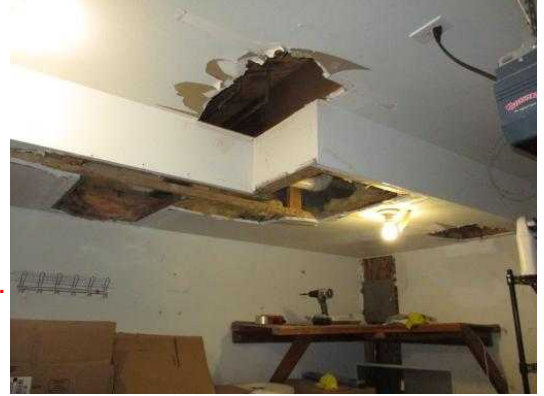
Sheetrock had been removed from areas of the garage wall and ceiling. It is recommended by that separation between the garage and the residence be maintained using 5/8" Type X gypsum board or equivalent when a habitable room exists above the garage. The floor joist cavities should be properly insulated before the sheetrock ceiling is re-installed. Recommend repairs be completed by a qualified contractor to establish proper separation for safety.

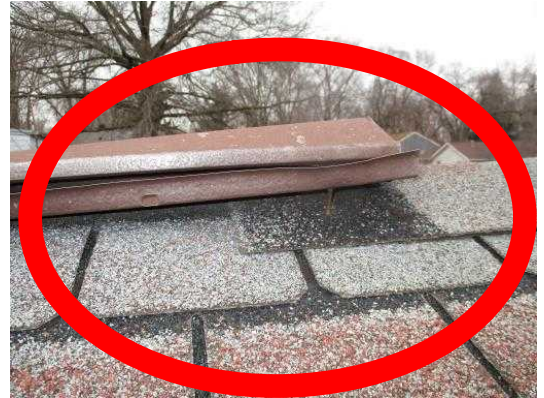
The East end of the ridge vent above the kitchen / dining area was loose. Recommend servicing be completed to resecure the ridge vent for weather / pest protection.

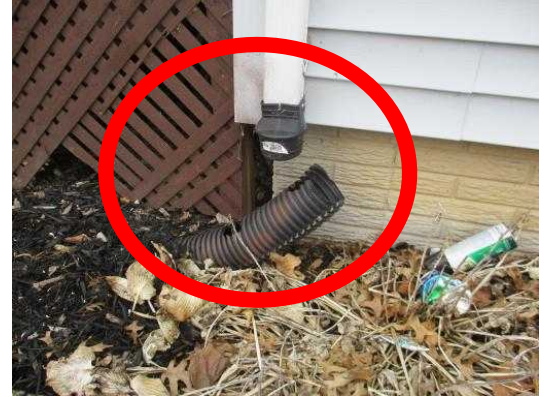
The downspout at the East side of the dwelling was separated from the below ground drain pipe. Recommend servicing / repairs be completed as necessary to provide a secure connection and verify proper drainage.

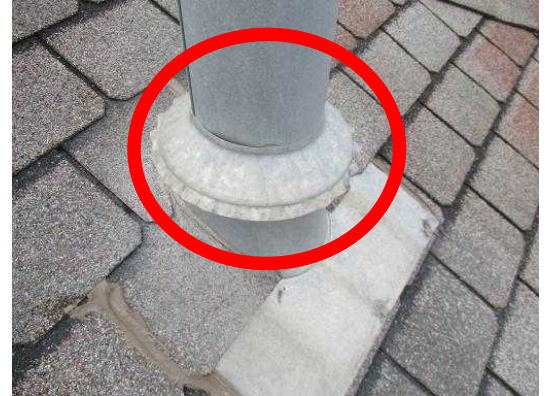
Recommend the storm collar to B vent pipe joint be sealed to help ensure proper weather protection is maintained at this area.

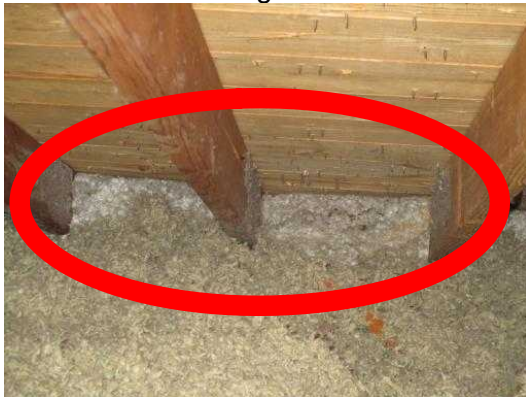
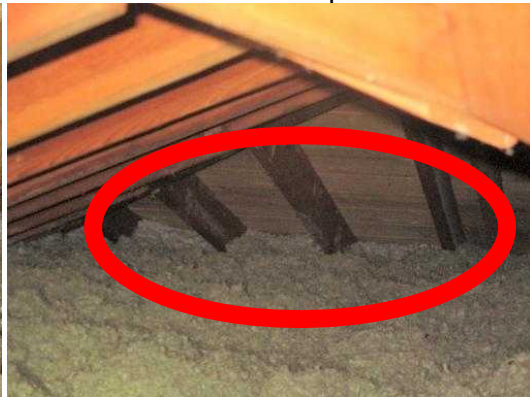
Soffit vents existed in the exterior eave, but did not appear to be open to the attic area at the time of the inspection. Corrective measures to remove obstruction and allow airflow into the attic area through the soffit vents should be considered for improved ventilation.

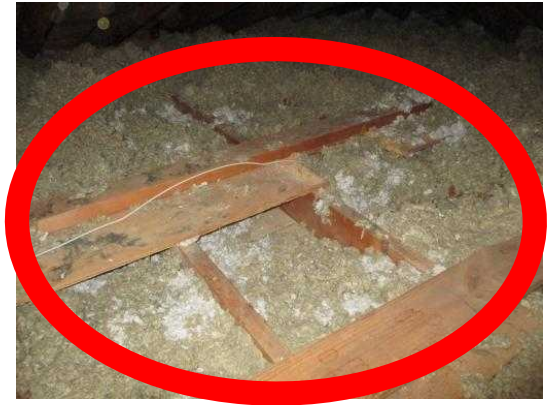
The R value of the undisturbed insulation (based on representative sample measurements) at the dwelling's accessible attic area was estimated to be ~R20-30. Insulation totaling R49 above the dwelling's living area is recommended by current standards for added efficiency. Suggest additional insulation be installed as desired for added efficiency.

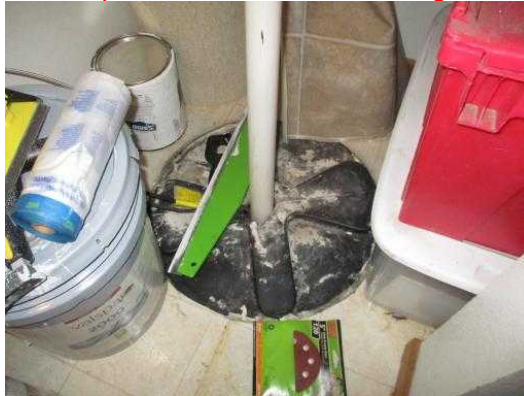
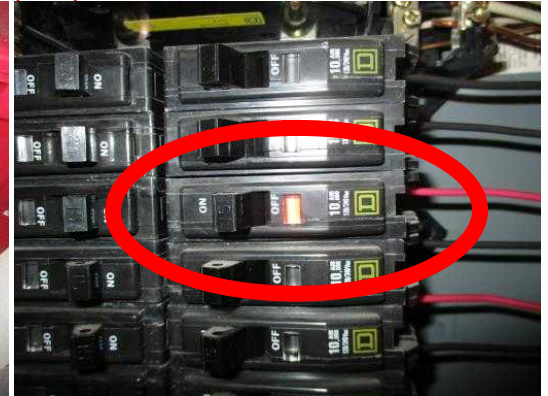
The sump pump did not respond to raising the float, and tripped the electrical circuit breaker when the pump was plugged directly into the wall outlet. Recommend the sump pump be replaced by a qualified contractor. The sump pump cover is a component of the active radon mitigation system and should be properly sealed in an air tight manner after a new pump is installed. Providing a sealed access opening in the sump pit lid is also suggested for maintenance inspection and routine testing of the pump.

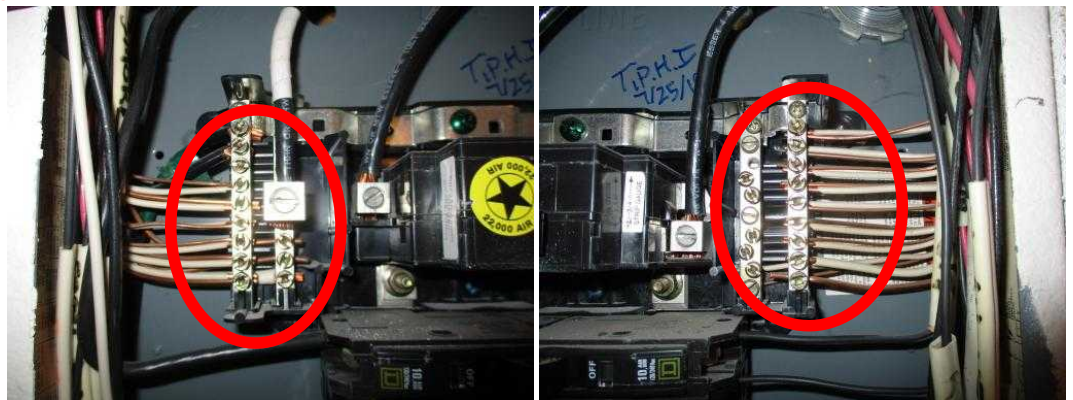
5. Priority Item, Non Functional **Enclosure:**
- Multiple conductors had been installed within single terminals on neutral / ground bus bars (double tapped) within the electrical panel. While this was not an uncommon practice in the past, installation of multiple conductors per lug where the neutrals are secured can result in a loose connection which is a safety concern. Installation of only one neutral conductor per lug terminal is recommended for safety. Recommend servicing be completed by a licensed electrician.

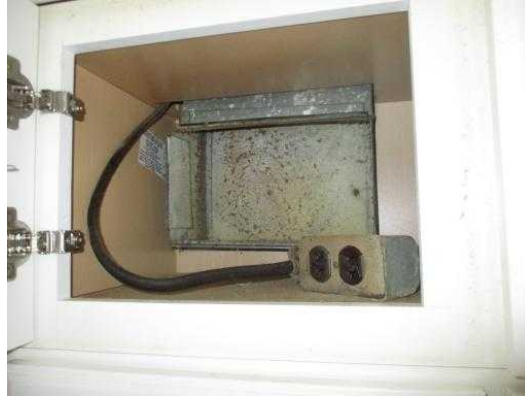
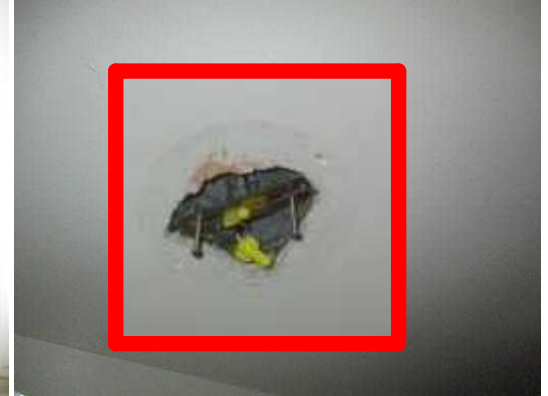
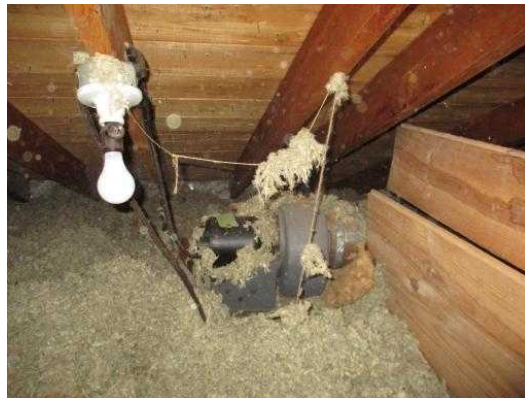
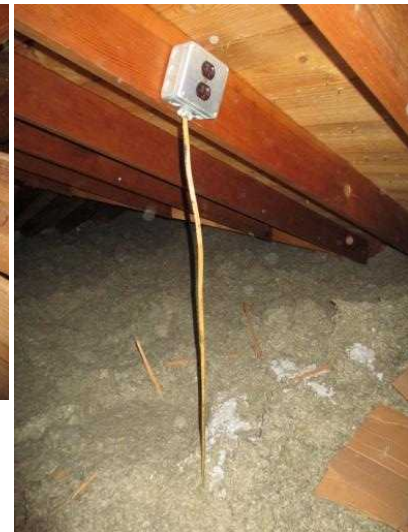
No power was noted at an older two prong outlet within the cabinet above the kitchen range. A missing junction box cover was noted at the upper level SE bedroom closet. What appeared to be a blower fan was also observed in the attic, connected to the same electrical circuit as a light fixture and outlet. It is possible that these electrical circuit(s) were terminated when the house was moved. If no longer in used, general recommendations are for the electrical components to be removed, discontinued, and or protected.

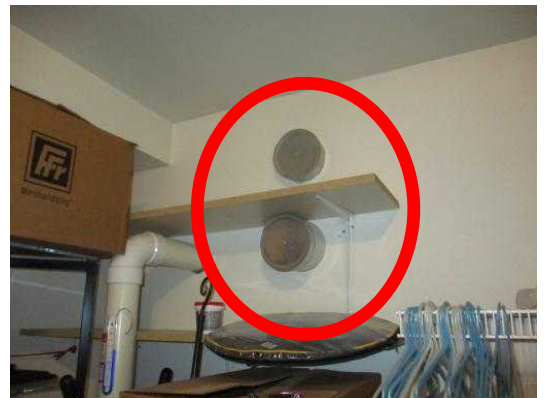
The interior side of two vent ducts had been capped at some time. These ducts were likely originally installed to provide a source of combustion air into the mechanical / laundry room area. The mechanical / laundry room was open to the lower level family room through a pet access in the door. Installation of an additional opening in the upper portion of the door, or interior wall should be considered to help ensure adequate combustion air is available. If the interior door is going to be repaired / replaced, opening the original exterior combustion air vents is recommended. The current exhaust type vent covers should be replaced with intake type covers to allow for proper airflow if used.

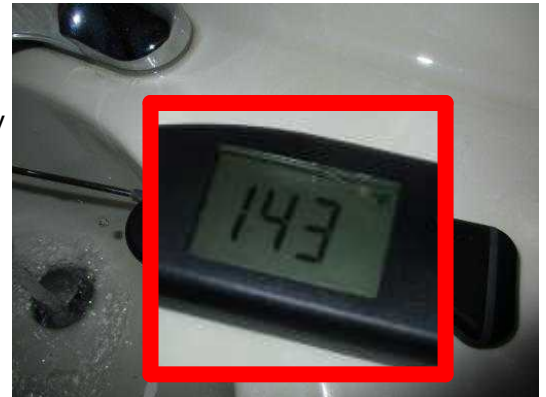
The hot water temperature tested 143° F. at the time of the inspection. Recommend the temperature control be set lower, to approximately 120° F. for added safety and energy savings. Recommend monitor/maintain the water temperature. If the water temperature is adjusted at the hot water heater, the individual high limit settings at the bathroom bathtub / showers may also need to be adjusted.

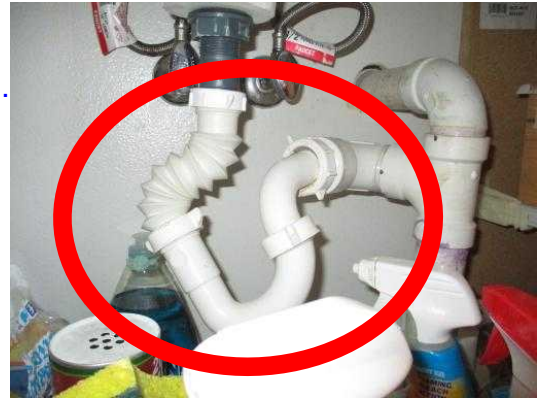
The drain piping below the lower level bathroom sink was poorly installed using a flexible / corrugated section of pipe. This type of drain plumbing is not approved by the UPC and is more susceptible to clogs or leakage. General recommendations are to upgrade to rigid PVC drain pipe.

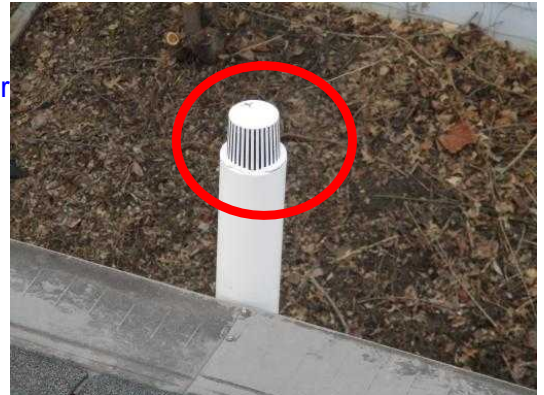
A cap had been installed on the end of the exterior radon vent pipe. This cap is prone to frost closure during the winter months. Recommend it be removed.

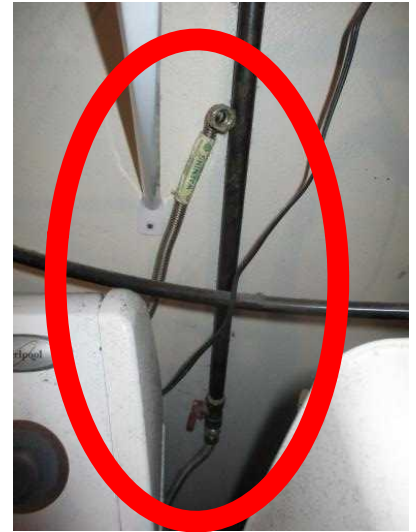
The unused / uncapped end of a gas line was located behind the clothes dryer appliance. Recommend the flexible appliance connector be removed, discarded, and the gas line be capped while not in used for safety.

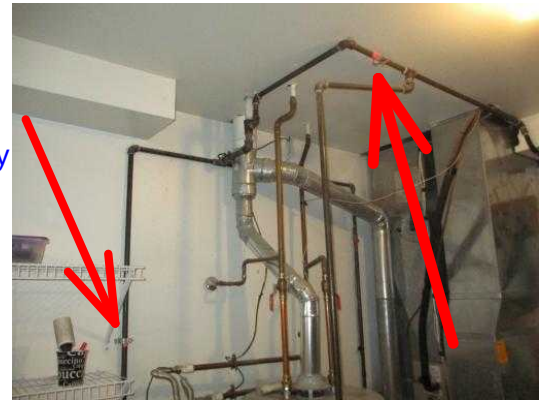
Two brackets that had been used to brace the gas line at the lower level mechanical area were no longer secured in place at the time of the inspection. Recommend corrective measures be completed to ensure the gas line is adequately braced / secured at this area.

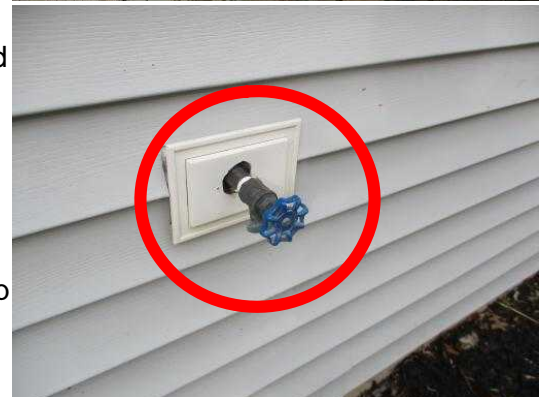
The use of an exterior rated vacuum breakers is recommended where not integrated into the hose bib to help prevent contaminating the the home's, or even the public's potable water supply.

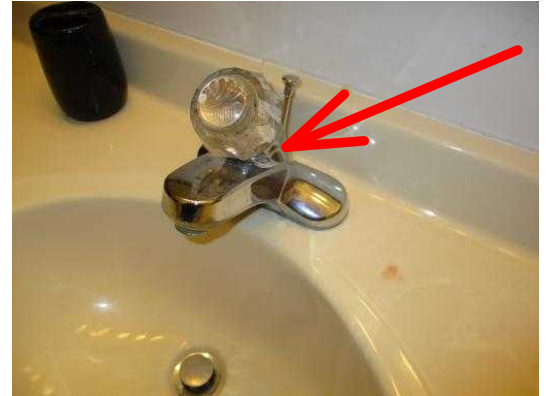
Leakage from the sink faucet was noted accumulating on the vanity top when operated during the inspection. Recommend repairs be completed to correct this leakage. Replacing the faucet's cartridge may be necessary.

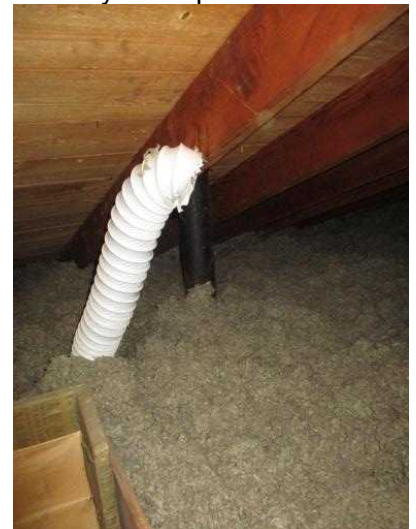
The bathroom fan was vented into the attic (which is not uncommon for this age of construction). Humid air vented into the attic with use of the bathroom can cause condensation / moisture problems. By current standards, it is recommended that bathroom exhaust fans be vented directly to the exterior through an insulated duct.

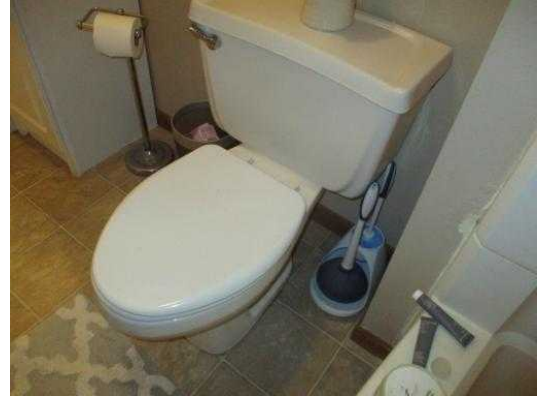
The lower level bathroom toilet was loose at the time of the inspection. Stains and signs of moisture were noted where the base of the toilet joined the floor. Recommend a licensed plumber complete repairs to properly secure the toilet and verify leak free operation. Based on the loose condition of the toilet and signs of moisture, recommendations are for the toilet's flange seal to be replaced.

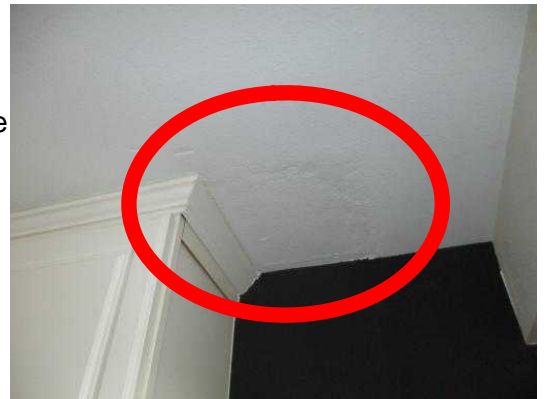
Non uniform texture / paint was noted at the kitchen ceiling just East of the wall cabinets. No stains or elevated moisture levels were noted during the inspection. Suggest ask the owner any knowledge of this condition and or repairs completed and monitor.

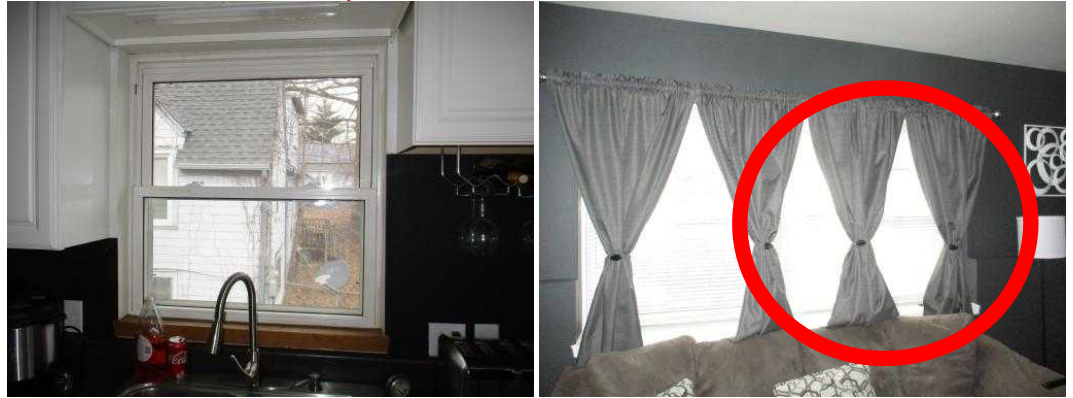
The kitchen and lower level family room NW windows could not be locked at the time of the inspection. This may be caused by the top and bottom sashes not aligning properly, and or being obstructed from closing completely. Recommend servicing be completed to allow these windows to be secured in a locked position.

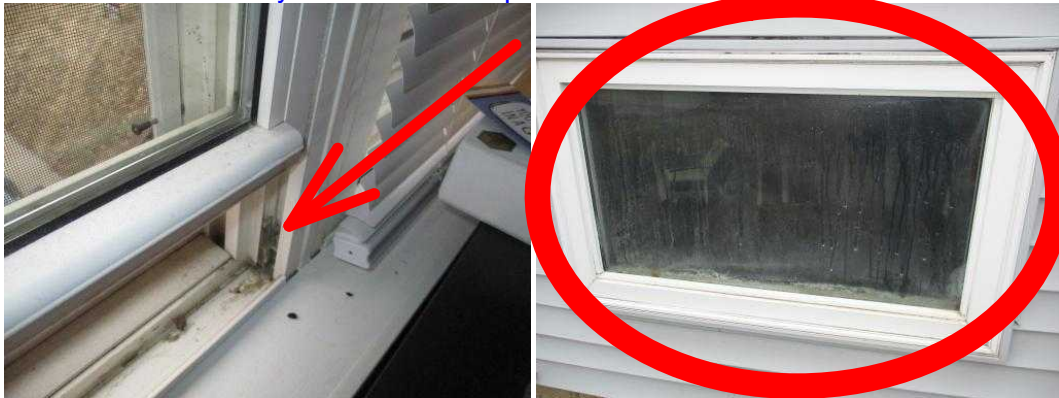
Significant condensation / discoloration was noted between the glass panes at the lower level laundry room window. This is typically a result in failure of the seal between the two panes and generally considered a cosmetic condition in this age window(s), but can impede the the ability to see through all parts of the glass. This type of condition can improve / worsen with different temperatures or humidity levels and it is possible that other seal failure exist that were not easily visible / identifiable for inspection. The insulated glass unit or window sash may be able to be replaced to correct this condition if desired.

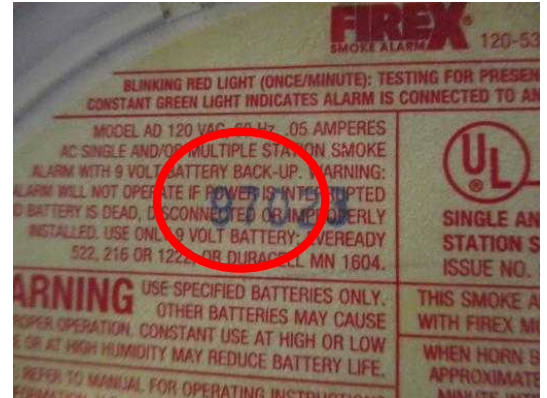
The smoke alarms at the upper level SE bedroom, and upper level bedroom hallway were past their expected productive life (~23 year) and therefore rated marginal. Industry recommendations are for smoke alarms to be replaced every 8-10 years (or sooner if necessary) for safety.

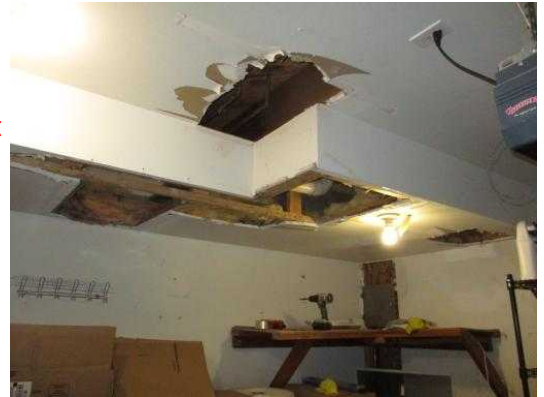
- 1. Separation:** Sheetrock had been removed from areas of the garage wall and ceiling. It is recommended by that separation between the garage and the residence be maintained using 5/8" Type X gypsum board or equivalent when a habitable room exists above the garage. The floor joist cavities should be properly insulated before the sheetrock ceiling is re-installed. Recommend repairs be completed by a qualified contractor to establish proper separation for safety.

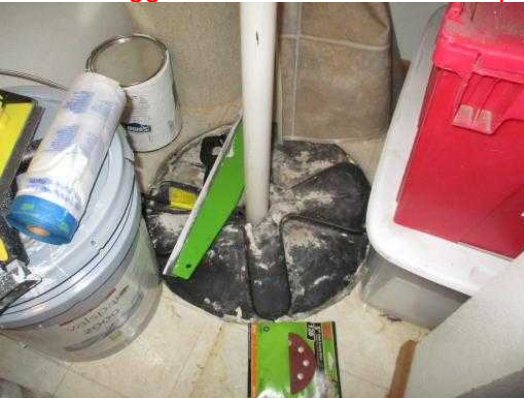
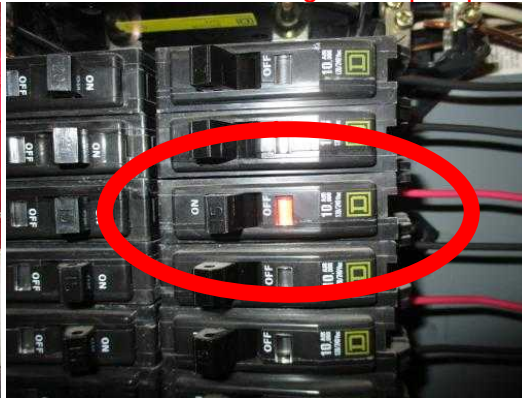
- 2. Sump Pit / Pump:** The sump pump did not respond to raising the float, and tripped the electrical circuit breaker when the pump was plugged directly into the wall outlet. Recommend the sump pump be replaced by a qualified contractor. The sump pump cover is a component of the active radon mitigation system and should be properly sealed in an air tight manner after a new pump is installed. Providing a sealed access opening in the sump pit lid is also suggested for maintenance inspection and routine testing of the pump.

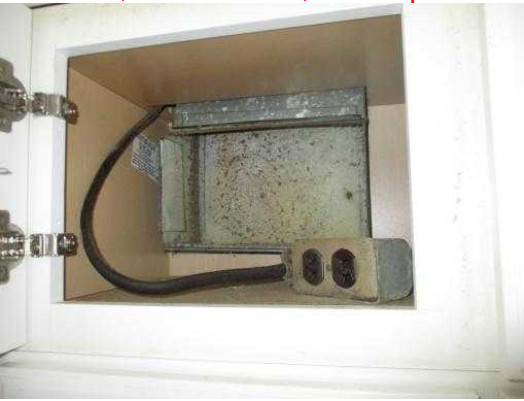
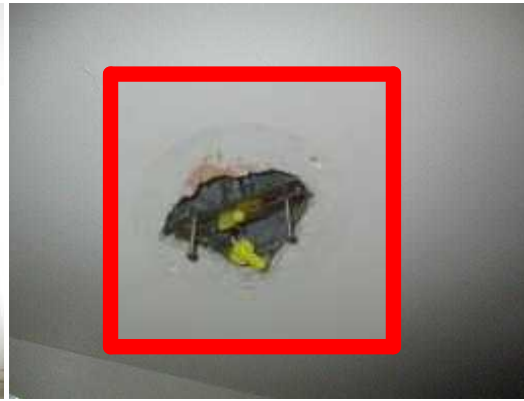
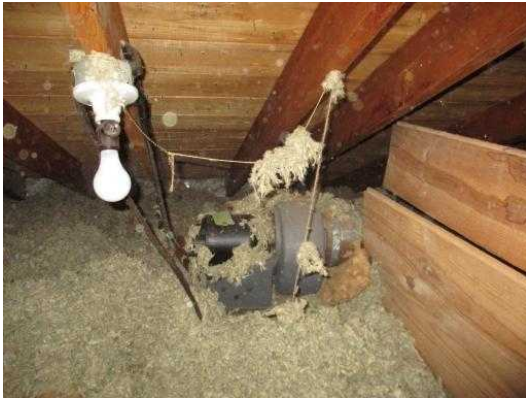
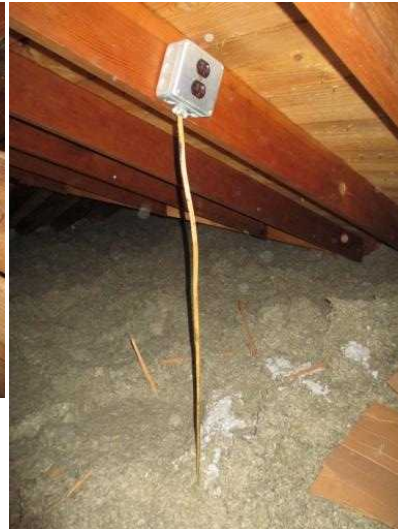
4. **Visible Branch Circuits (outlets, switches, wiring, etc.):** No power was noted at an older two prong outlet within the cabinet above the kitchen range. A missing junction box cover was noted at the upper level SE bedroom closet. What appeared to be a blower fan was also observed in the attic, connected to the same electrical circuit as a light fixture and outlet. It is possible that these electrical circuit(s) were terminated when the house was moved. If no longer in used, general recommendations are for the electrical components to be removed, discontinued, and or protected.

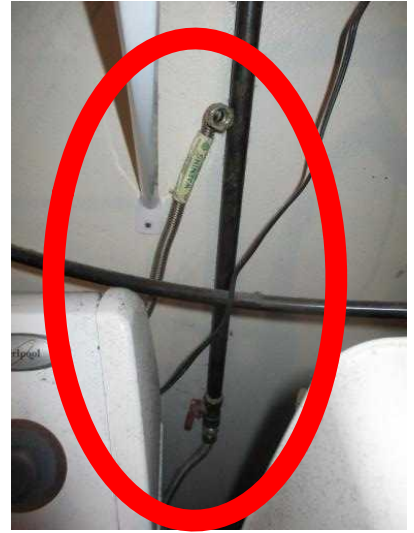
5. **Gas Line:** The unused / uncapped end of a gas line was located behind the clothes dryer appliance. Recommend the flexible appliance connector be removed, discarded, and the gas line be capped while not in used for safety.

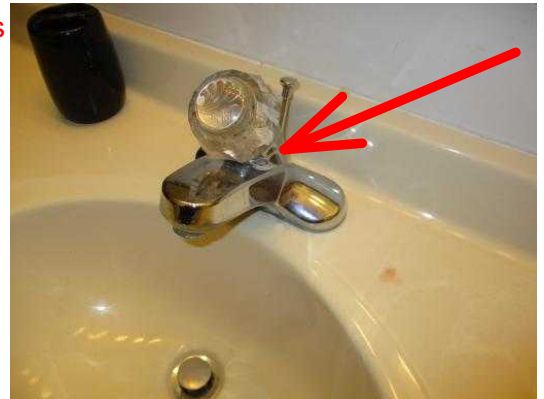
6. **Upper Level Hallway Bathroom Sink:** Leakage from the sink faucet was noted accumulating on the vanity top when operated during the inspection. Recommend repairs be completed to correct this leakage. Replacing the faucet's cartridge may be necessary.

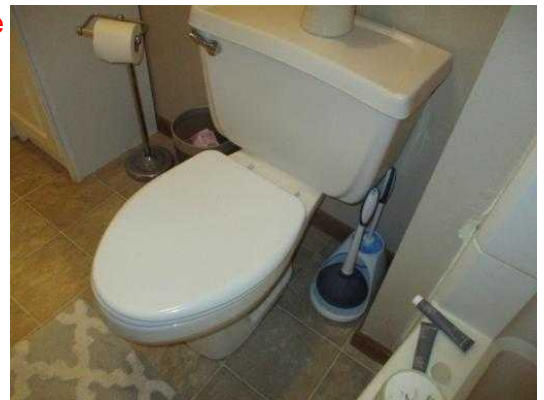
7. **Lower Level Bathroom Toilet:** The lower level bathroom toilet was loose at the time of the inspection. Stains and signs of moisture were noted where the base of the toilet joined the floor. Recommend a licensed plumber complete repairs to properly secure the toilet and verify leak free operation. Based on the loose condition of the toilet and signs of moisture, recommendations are for the toilet's flange seal to be replaced.

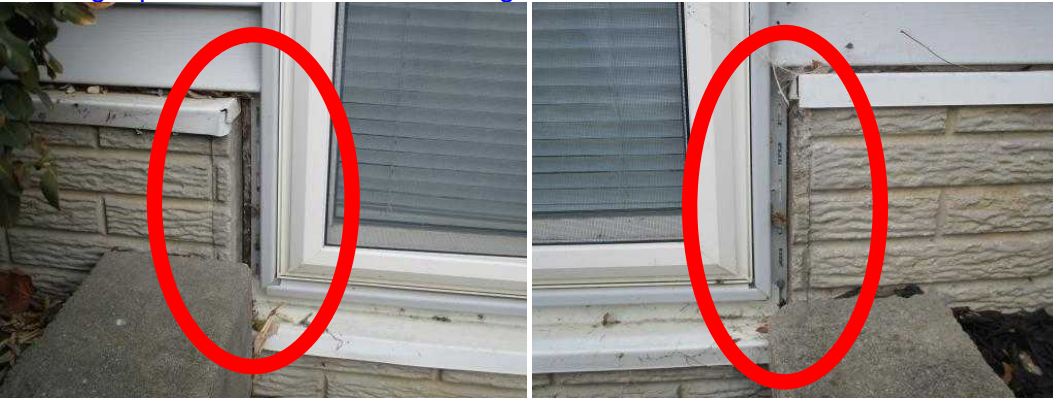
1. **Exterior Windows / Trim:** The basement family room's West window lacked a weather resistant barrier and trim at the lower corners (between the window and the concrete foundation). Installation of an adhesive window flashing tape and trim or other cladding material is recommended for better weather protection.

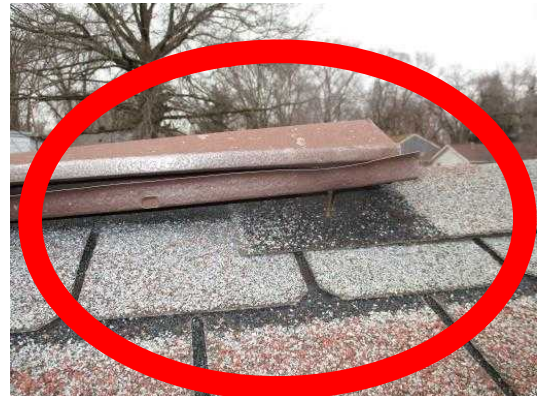
2. **Flashing:** The East end of the ridge vent above the kitchen / dining area was loose. Recommend servicing be completed to resecure the ridge vent for weather / pest protection.

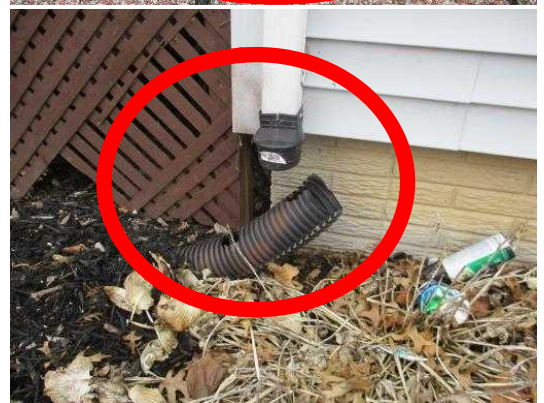
3. **Downspouts:** The downspout at the East side of the dwelling was separated from the below ground drain pipe. Recommend servicing / repairs be completed as necessary to provide a secure connection and verify proper drainage.

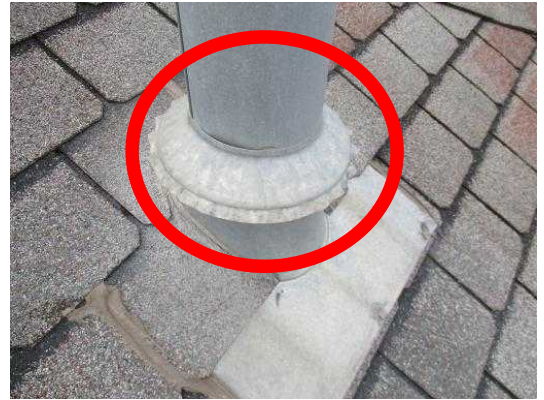
4. **Exterior Chimney / Vent:** Recommend the storm collar to B vent pipe joint be sealed to help ensure proper weather protection is maintained at this area.

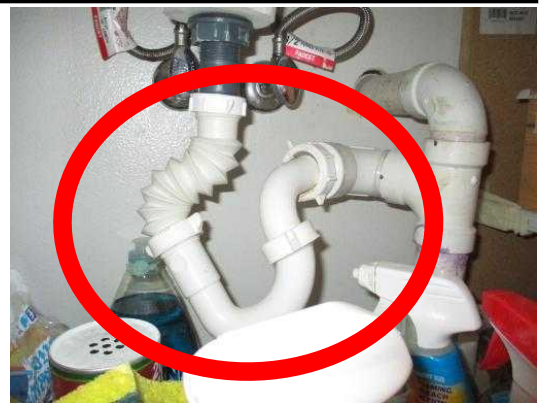
5. **Drain / Vent Plumbing:** The drain piping below the lower level bathroom sink was poorly installed using a flexible / corrugated section of pipe. . This type of drain plumbing is not approved by the UPC and is more susceptible to clogs or leakage. General recommendations are to upgrade to rigid PVC drain pipe.

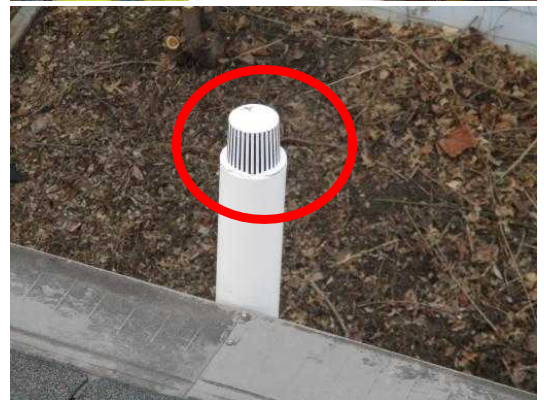
6. **Radon Vent Pipe:** A cap had been installed on the end of the exterior radon vent pipe. This cap is prone to frost closure during the winter months. Recommend it be removed.

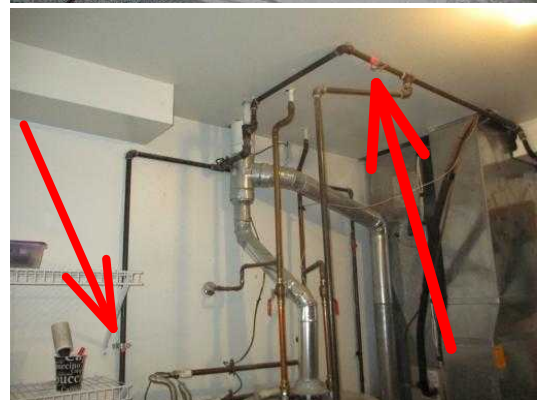
7. **Gas Line:** Two brackets that had been used to brace the gas line at the lower level mechanical area were no longer secured in place at the time of the inspection. Recommend corrective measures be completed to ensure the gas line is adequately braced / secured at this area.

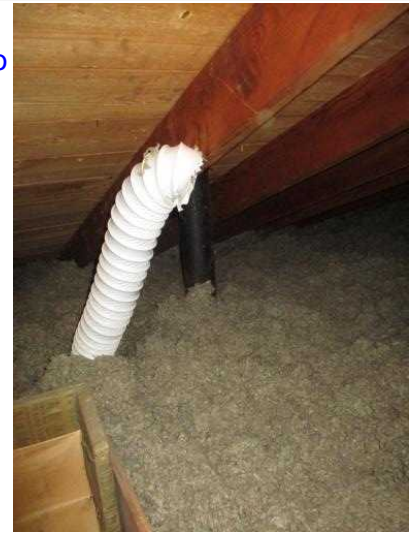
8. **Upper Level Hallway Bathroom Exhaust Fan:** The bathroom fan was vented into the attic (which is not uncommon for this age of construction). Humid air vented into the attic with use of the bathroom can cause condensation / moisture problems. By current standards, it is recommended that bathroom exhaust fans be vented directly to the exterior through an insulated duct.

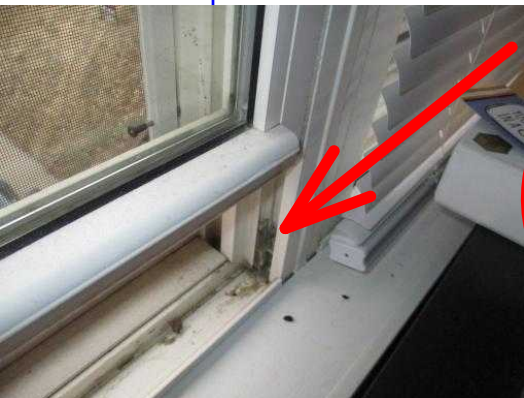
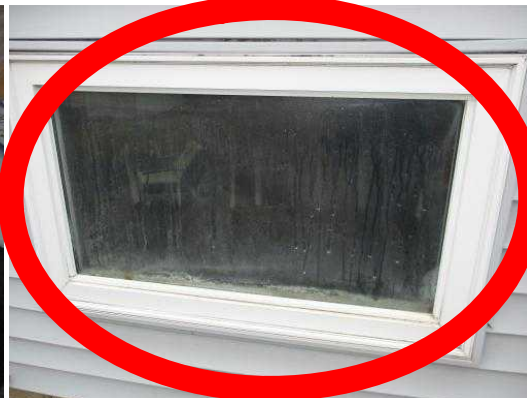
- Significant condensation / discoloration was noted between the glass panes at the lower level laundry room window. This is typically a result in failure of the seal between the two panes and generally considered a cosmetic condition in this age window(s), but can impede the ability to see through all parts of the glass. This type of condition can improve / worsen with different temperatures or humidity levels and it is possible that other seal failure exist that were not easily visible / identifiable for inspection. The insulated glass unit or window sash may be able to be replaced to correct this condition if desired.

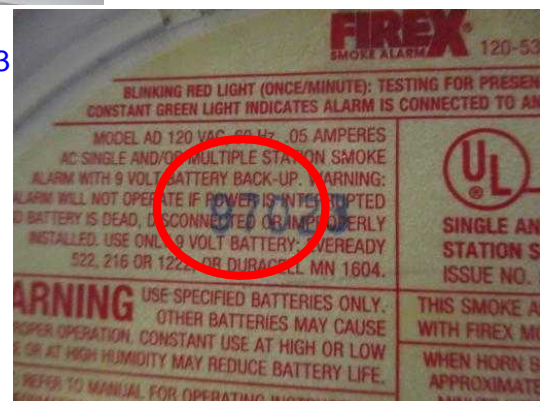
10. **Smoke Alarms:** The smoke alarms at the upper level SE bedroom, and upper level bedroom hallway were past their expected productive life (~23 year) and therefore rated marginal. Industry recommendations are for smoke alarms to be replaced every 8-10 years (or sooner if necessary) for safety.
