American Inspections, Inc.
403 Stonehaven Lane NE
Cedar Rapids, IA 52402

Professional Inspection Report

123 Example Rd
Iowa City, IA 52402

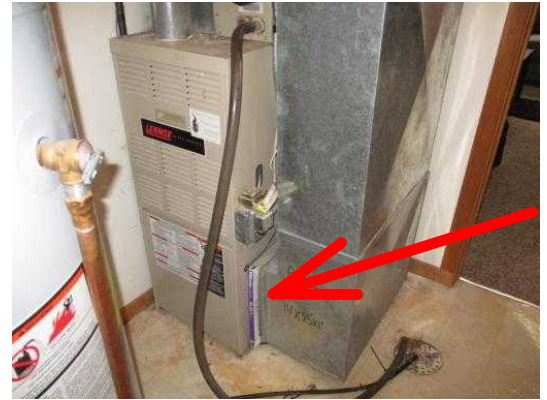
7. Functional

Recommend maintenance replacement of the HVAC filter be completed at least quarterly. Additional filter changes may be necessary depending interior conditions and use of the HVAC system. A photo of the filter access position was included for reference.

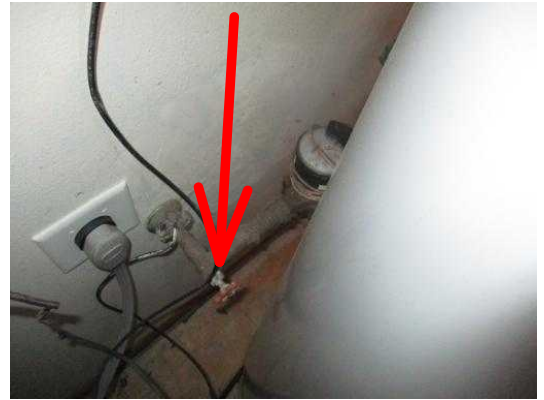
11. Functional

The dwelling's main water shut off valve is not operated during the inspection. A photo of the main water shut off valve(s) was included for reference.

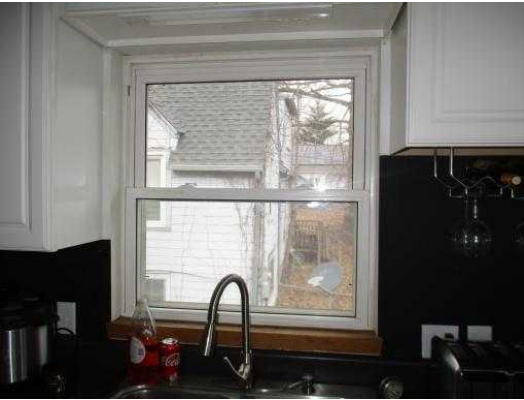
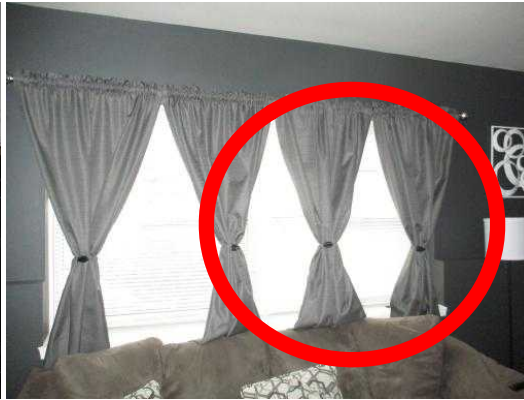
8. **Interior Windows (Primary):** The kitchen and lower level family room NW windows could not be locked at the time of the inspection. This may be caused by the top and bottom sashes not aligning properly, and or being obstructed from closing completely. Recommend servicing be completed to allow these windows to be secured in a locked position.
